Anti-Icing photos.

The following photos were taken in the eastern part state of Washington near the Columbia River on Highway 243. Even though the details of what product was applied, or how much, they are excellent examples of what “anti-icing” can accomplish. Note the ice on the shoulders and on the side road where anti-icing was not accomplished.

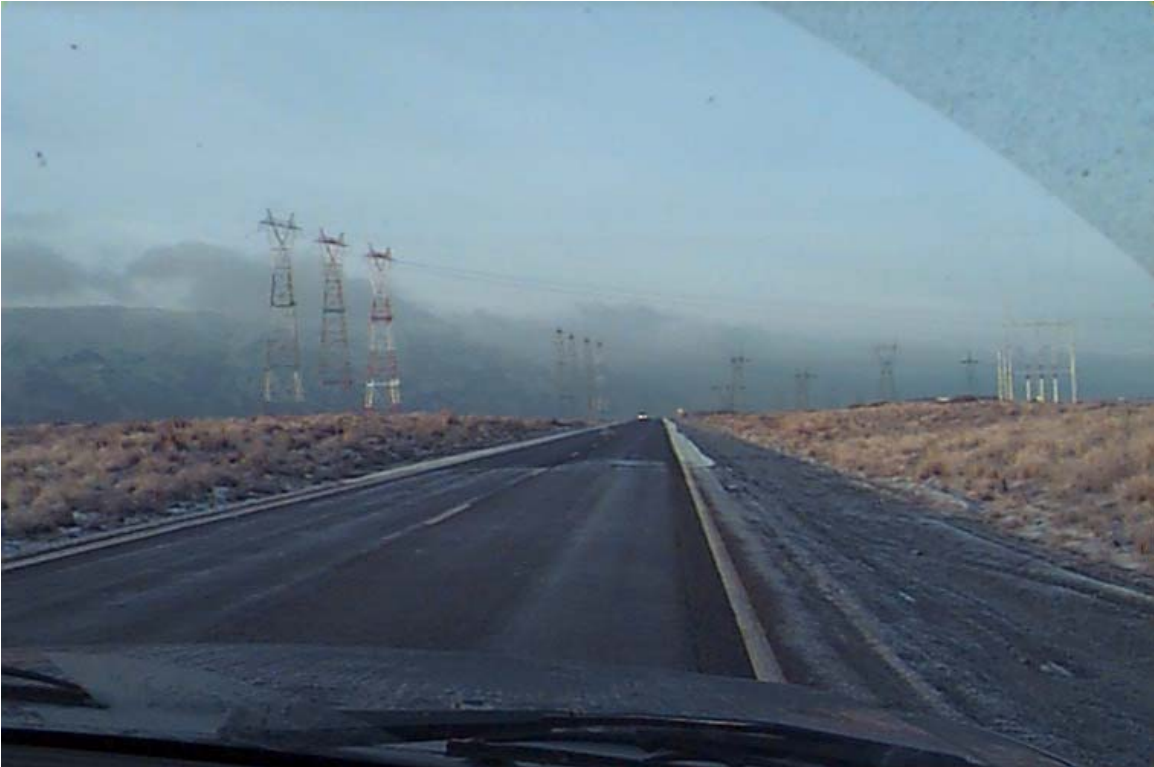
Photo 1. Note the ice outside of the application area on both sides of the highway

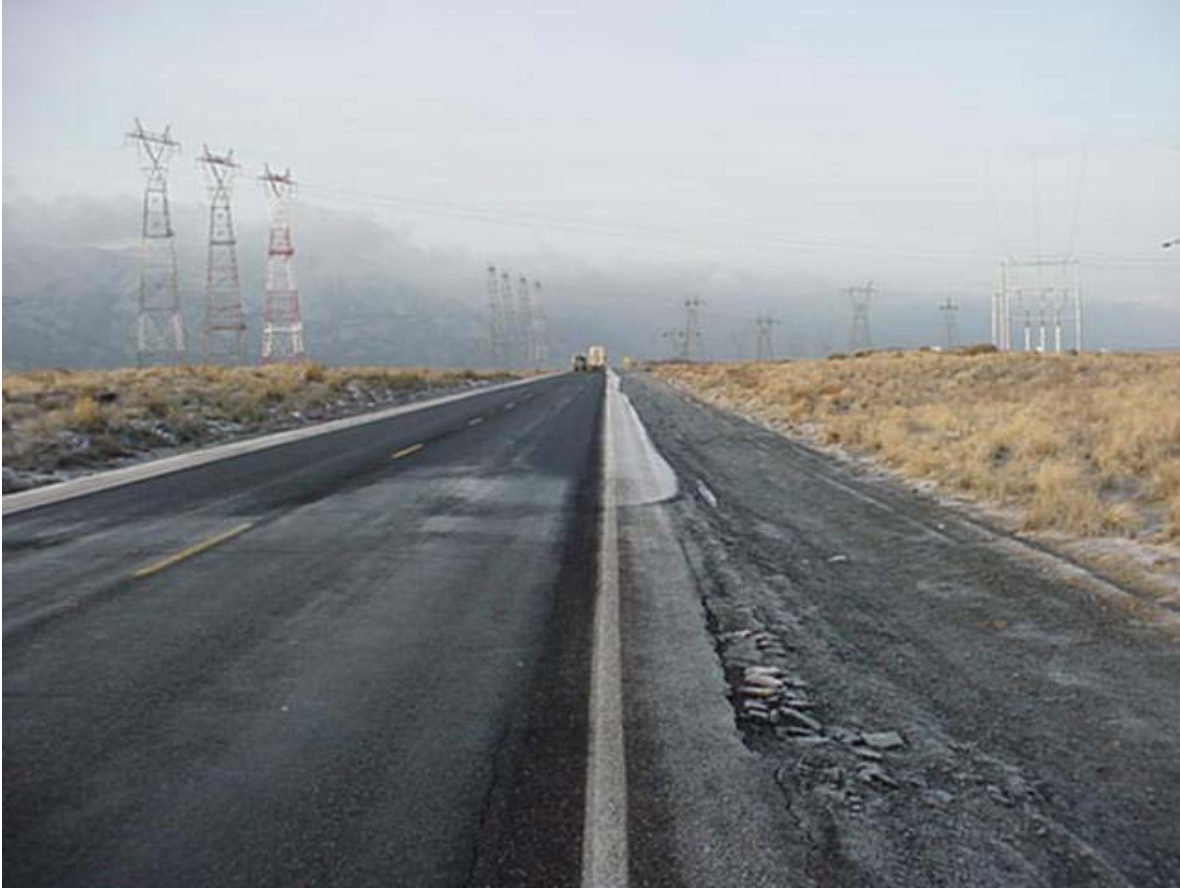
Photo 2. Note ice on shoulders and edge of roadway near edge lines. Just outside of the application area.

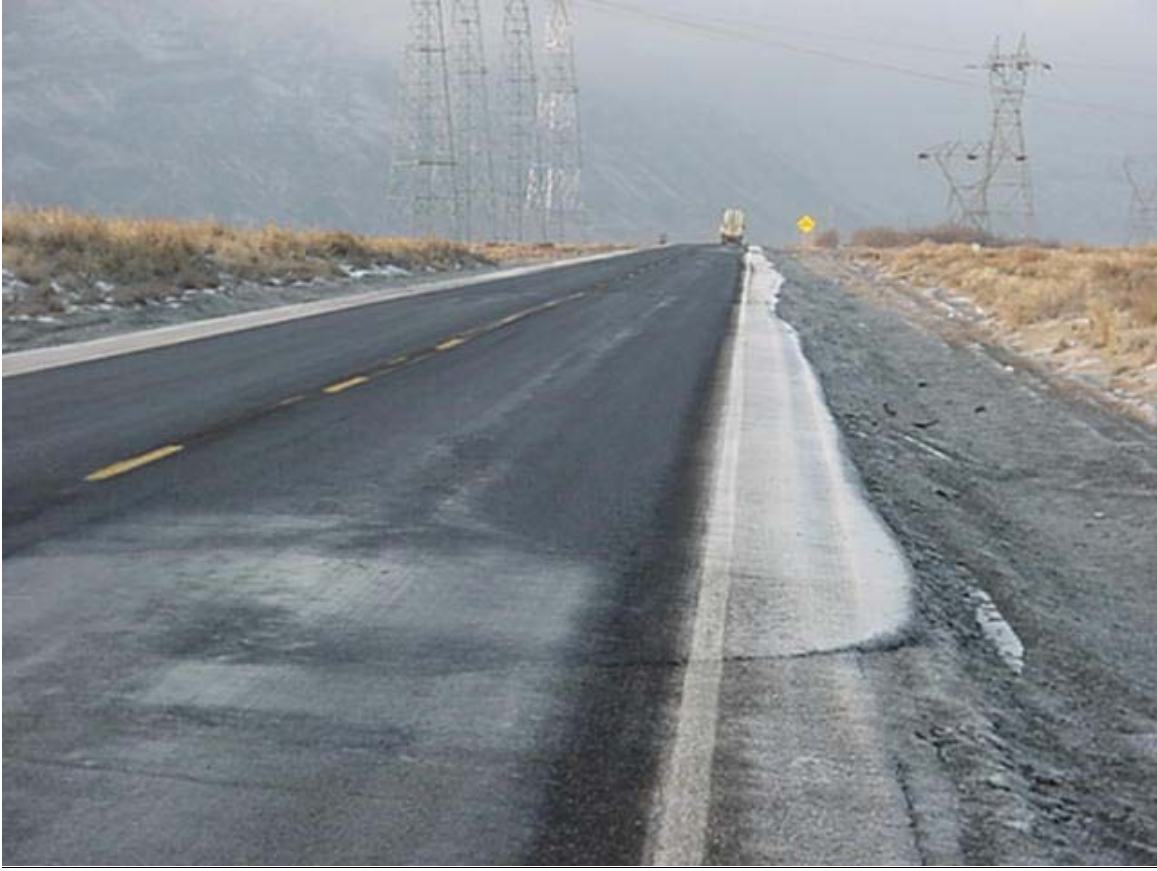
Photo 3. Close up of ice on shoulder just outside of application area.

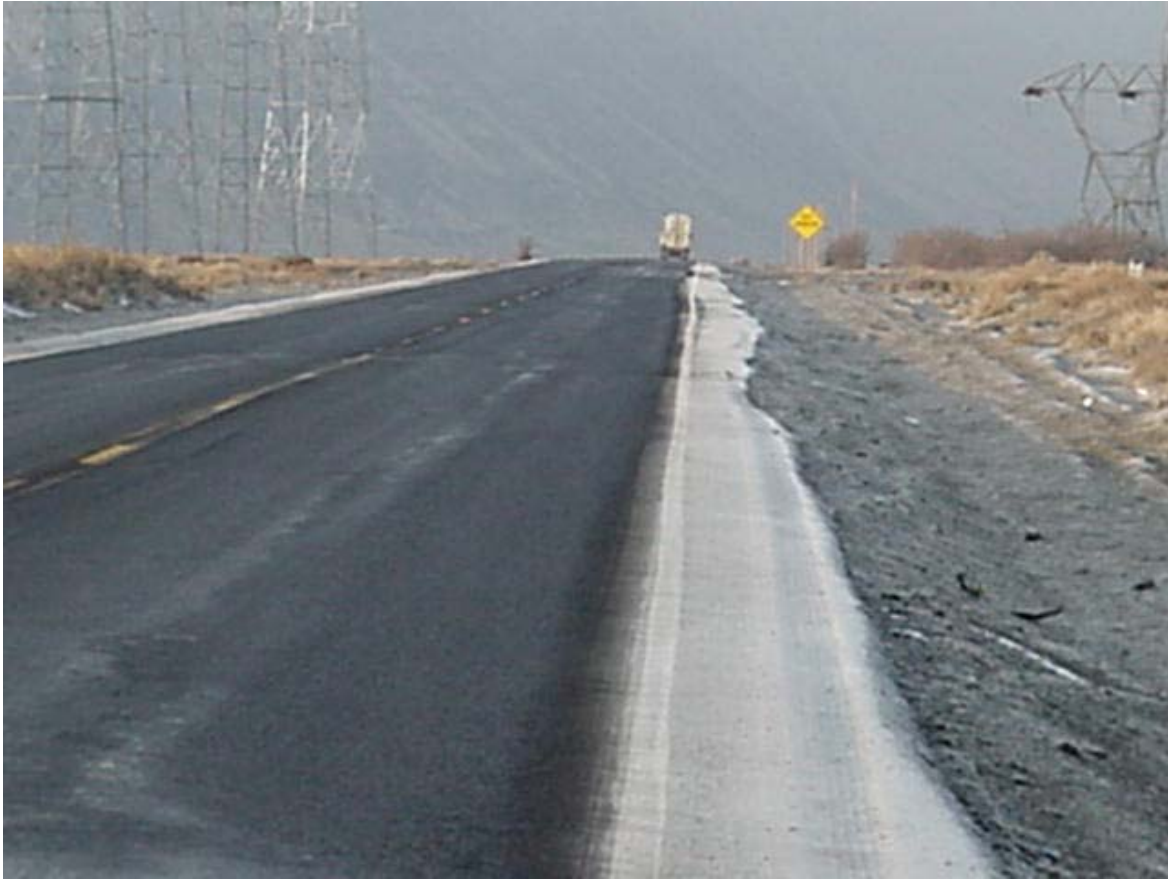
Photo 4. More icy shoulders with bare and wet road. Bare road is due to anti-icing application

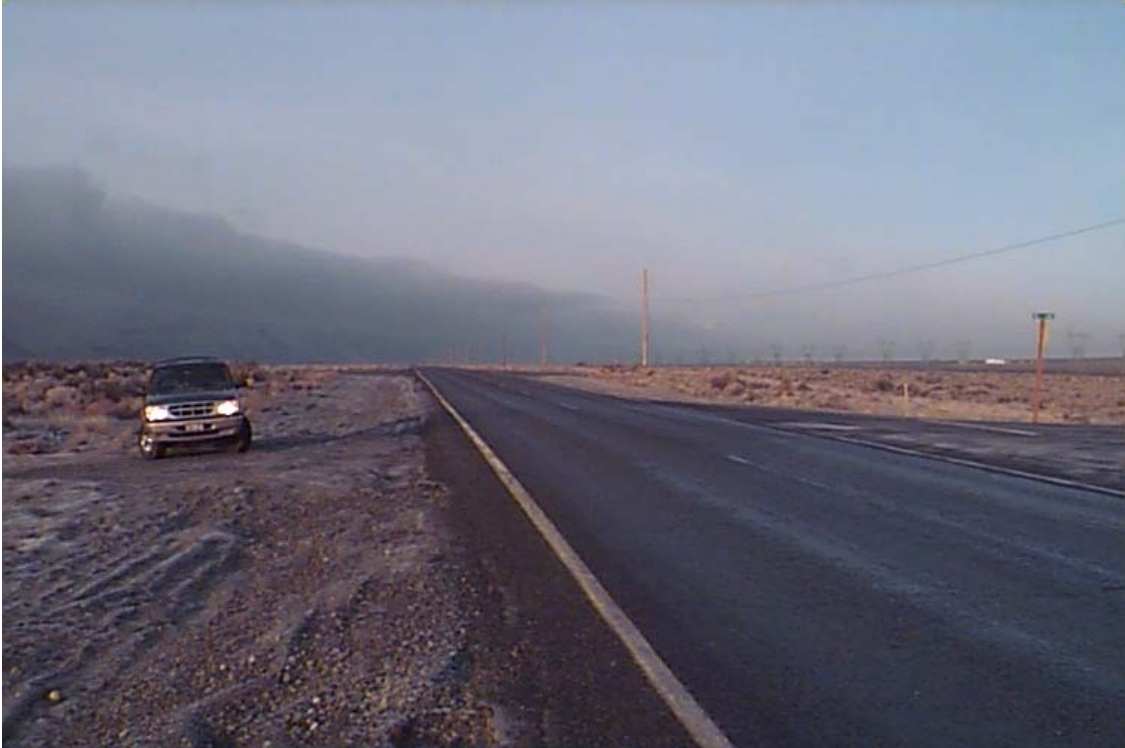
Photo 5. Note ice on side road that was untreated.

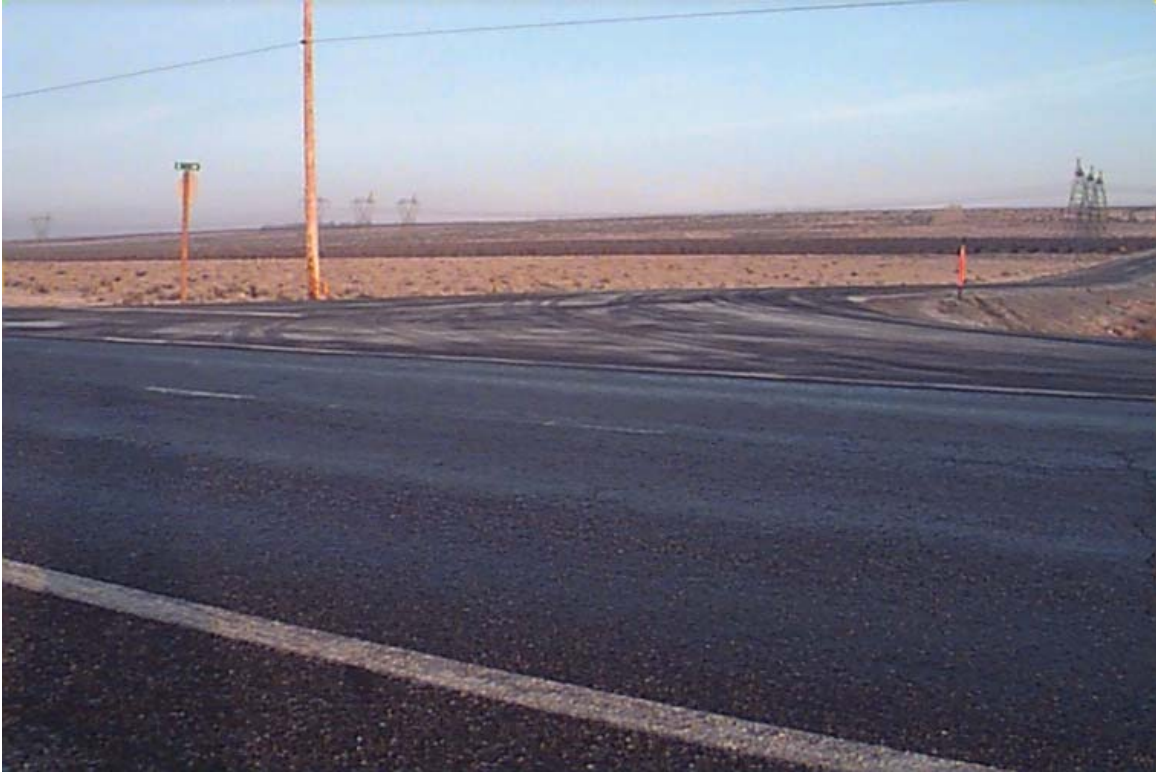
Photo 6. Note ice on untreated side road. Also note tracking of material and melting action on the side road.

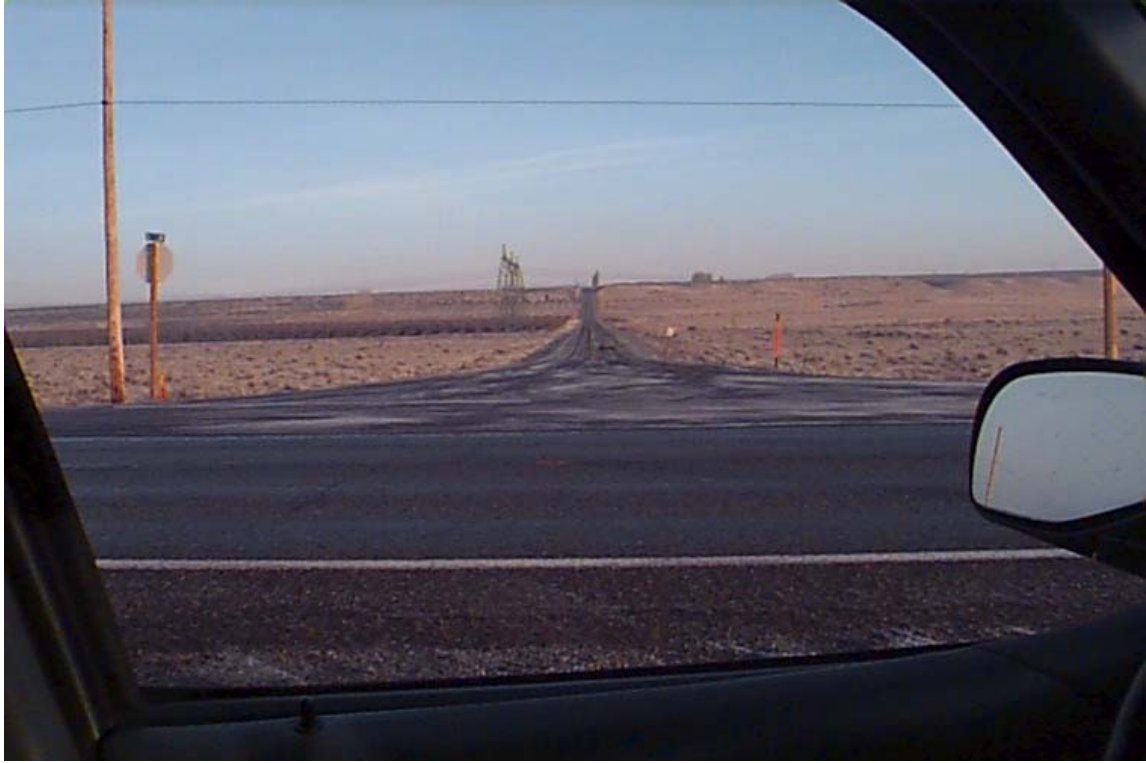
Photo 7. Untreated and icy side road.

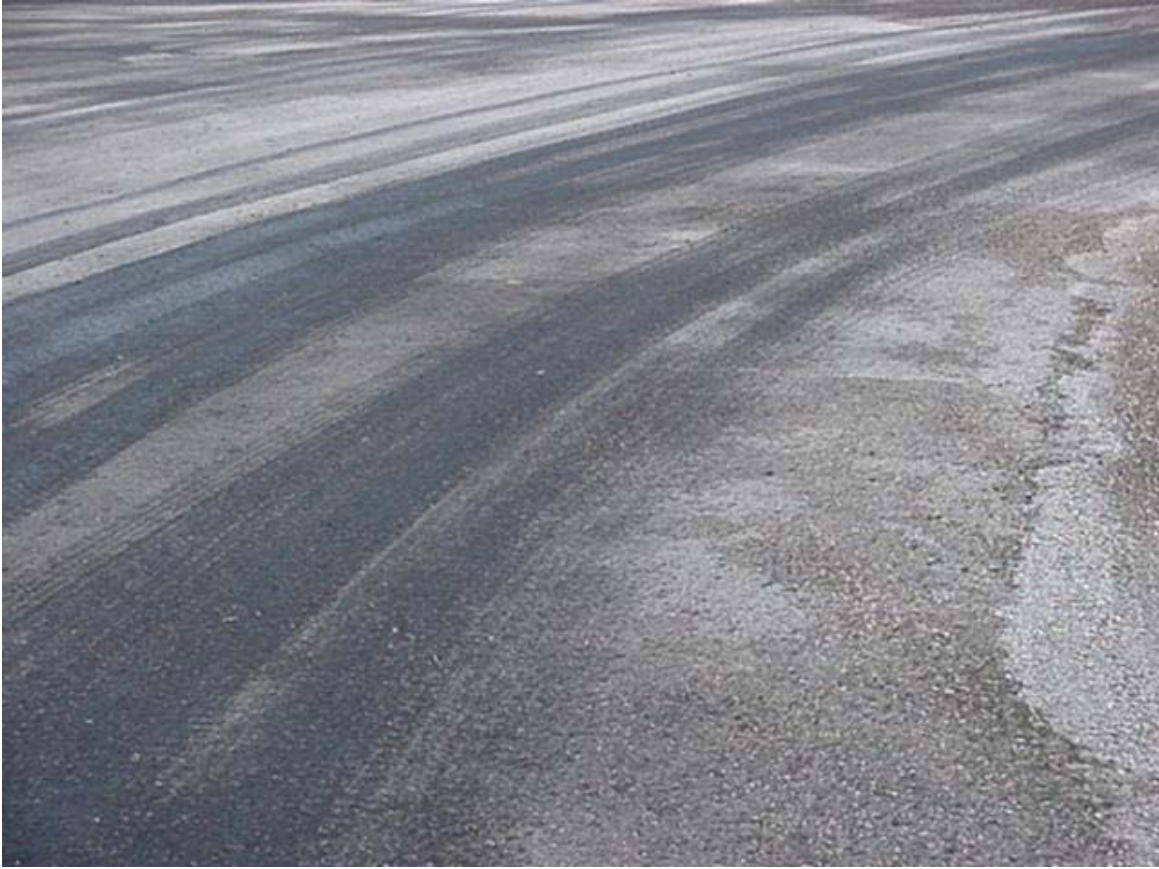
Photo 8. Untreated and icy side road.

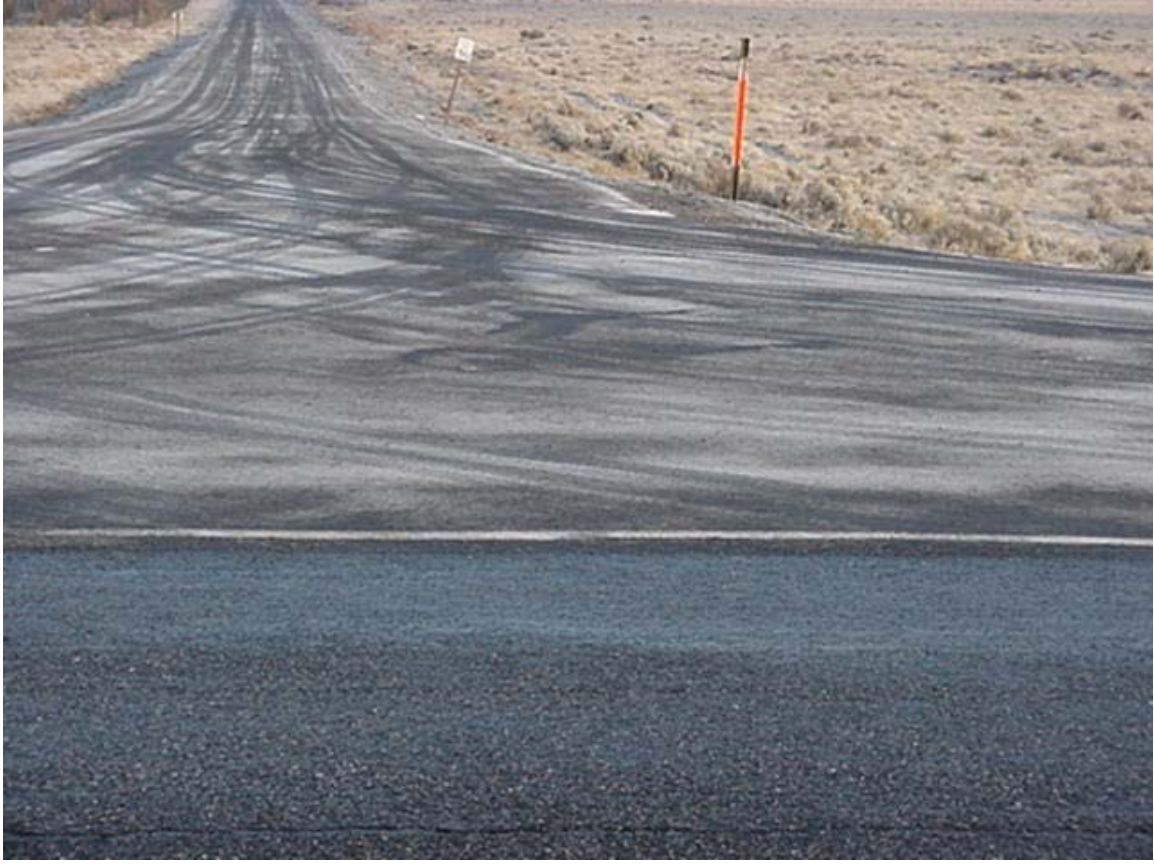
Photo 9. Untreated and icy side road.
